aiwa

SERVICE TECHNICAL INFORMATION

MODEL : TV-1402KE/2002KE/2102KE

SUBJECT : Part Number of EEP ROM (IC002/NVM3060)

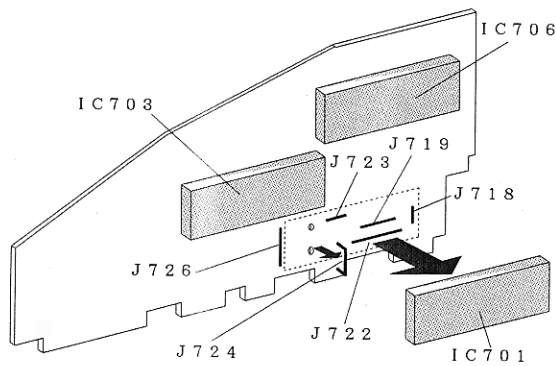
Fig-1

In the majority of the cases (43%) the symptoms did not recur. It is thought that this is because, in these cases, the jumper line mounted under the IC is connected to the GND pattern. For this reason, symptoms did not occur. For unstable units, perform the following remedy.

DIGITAL C.B (side with mounted parts)
As shown in the diagram, remove the ICs and then remove each jumper line.

1. Remove IC701, IC703, and IC706. (See Fig. 1.)
2. Remove all jumper lines mounted under IC. (See Fig. 1.)

Under IC701:	J718/ J719/ J722/ J723/ J724/ J726	} Total of 22 lines.
Under IC703:	J746/ J747/ J748/ J749/ J751/ J752/ J792	
Under IC706:	J754/ J757/ J758/ J759/ J760/ J761/ J762/ J763/ J764

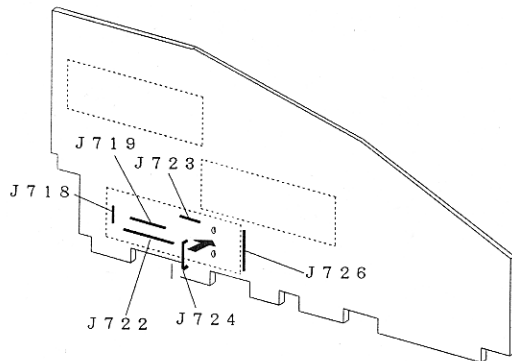
Fig-2

DIGITAL C.B (Pattern side)
Attach the removed jumper lines to the pattern surface and solder. At this time, make sure that jumper lines are not too long that they protrude over to the side with the mounted parts.

3. Attach the removed jumper lines to the pattern surface on the reverse side. (See Fig. 2)

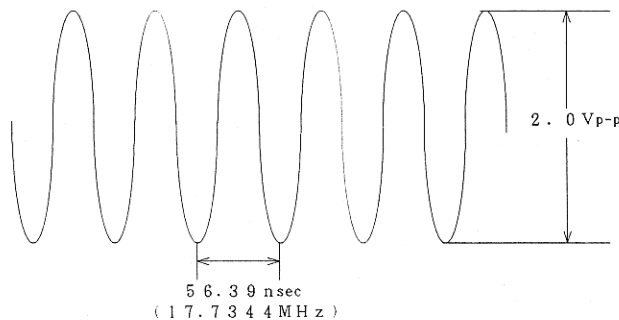
X701 Waveform

There have also been many cases of faulty X701s and faulty soldering. When repairing DIGITAL C.B, always confirm that X701 operates correctly. (See below.)

Note: Voltage of the observed waveform changes in accordance with input impedance and the input amount from probes and oscilloscopes used for measurements.

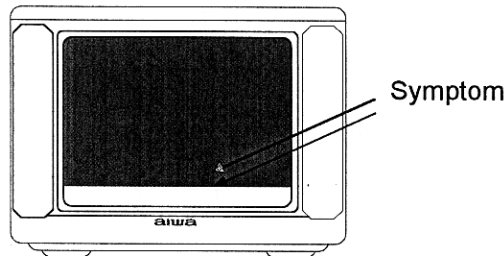
- MODEL : TV-A205 KER/TV-A145 KER
 SUBJECT : Horizontal line appears at bottom of screen
 SYMPTOM : The bottom portion of screen has vertical size compression, and a horizontal line appears at bottom of the screen due to degraded vertical linearity characteristics. (The symptom becomes recognizable after long-duration operation or under no-input status.)

ACTIONS : Replace the three resistors shown below.

R505	R512	R516	
Existing	82K-1/8W	1.8K-1/8W	180K-1/8W (*)	Correct value is 180K-1/8W. "180-1/8W" in S/M circuit diagram is wrong.
	↓	↓	↓	
After replacement	39K-1/8W	1.2K-1/8W	270K-1/8W

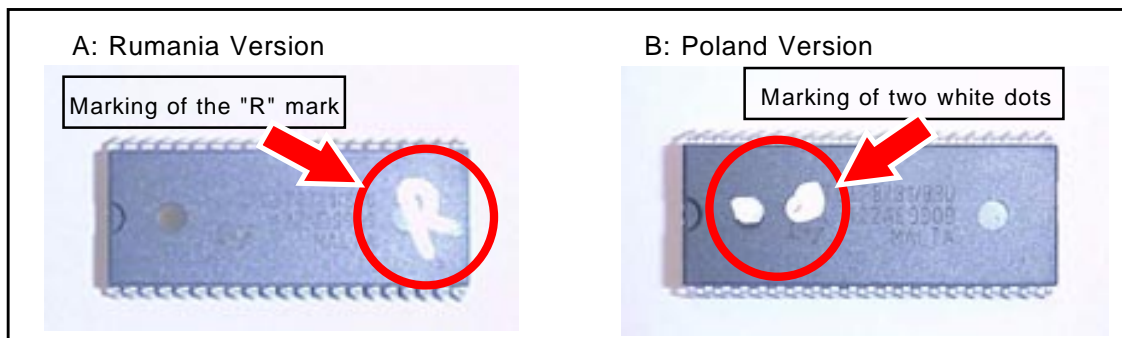
Method of discriminating between the microcomputer IC of different regional models

A:IC, ST6387-OTP 6373	Rumania Version	The mark "R" is present on the top surface of the IC.
B:IC, ST6387-OTP 6331	Poland Version	There are marks of two white dots on the top surface of the IC.

Please replace the component with the one specified below.

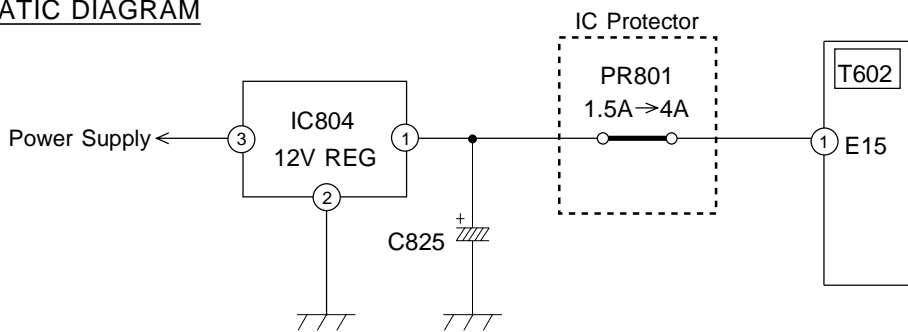
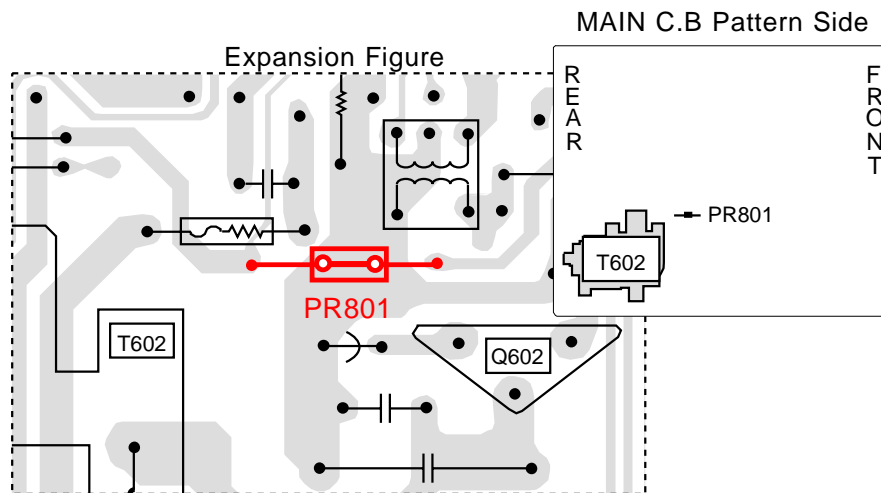
No power due to open IC PROTECTOR (ICP,PR 801) caused by a rush current.

Replace the IC Protector (PR801 1.5A)with one that has higher current capacity(4A).

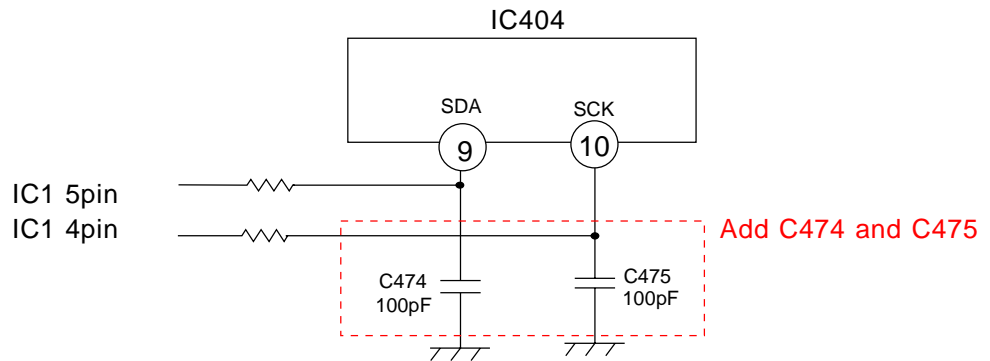
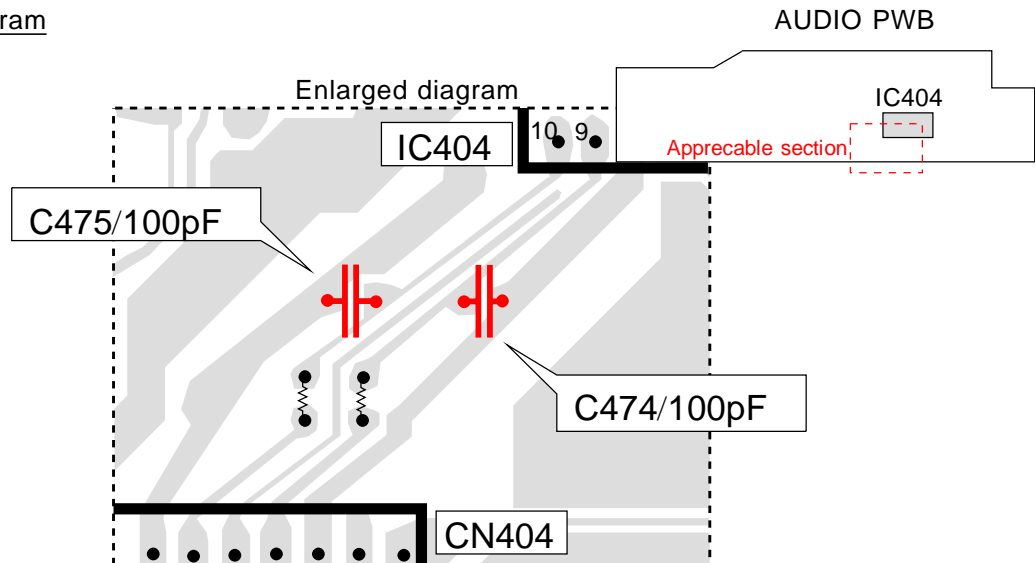
Noise enters into the data line(SDA/SCK) of IC404(volume controller) and causes the following symptoms.

Add a capacitor to the data line(SDA/SCK) of IC404(volume controller) and compose a noise filter(Lands are available).

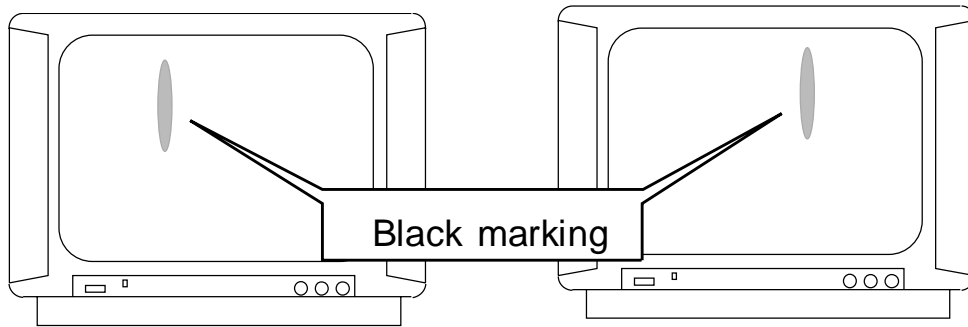
Black marking appear as shown below.
Appearing point defers according to the set.

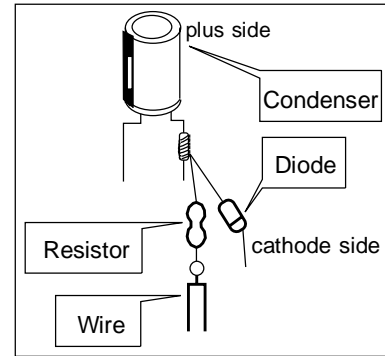
Fig1

No power on due to horizontal output transistor Q601 failure.
Take the following countermeasure in this case.

1. Replace Q601 after confirming PR801 is open.
2. Connect condenser, diode, resistor, and wire according to the drawing 1.

Be care to the direction of diode and condensor.

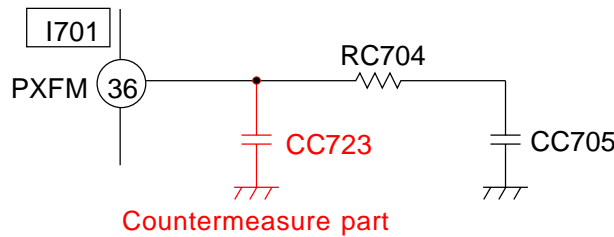
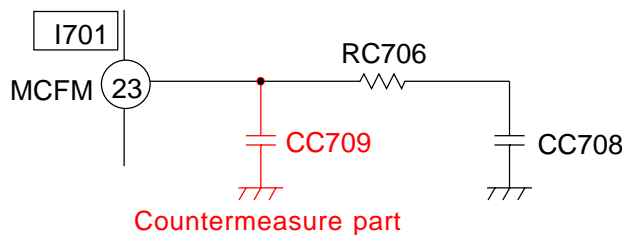
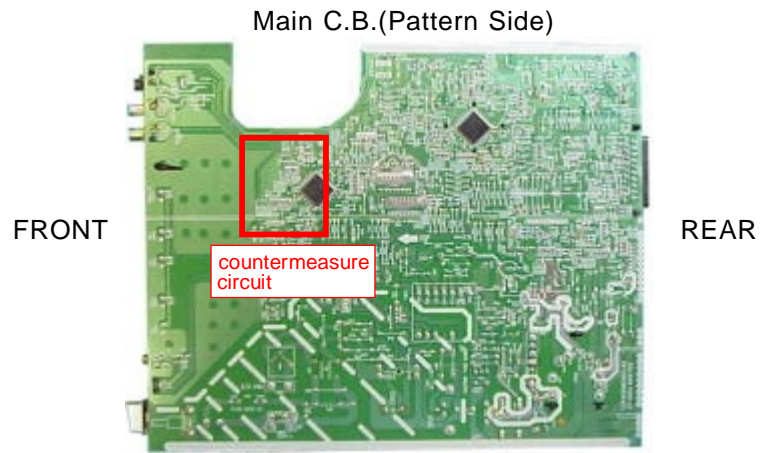
It may happen that " OSD does not display, standby LED does not light " as the flux causes to change the capacity of CC709,CC723.

By replacing the condenser CC709,CC723 from chip type to AXIAL type, the effect of flux reduces.(Please refer the next page for actual installation)

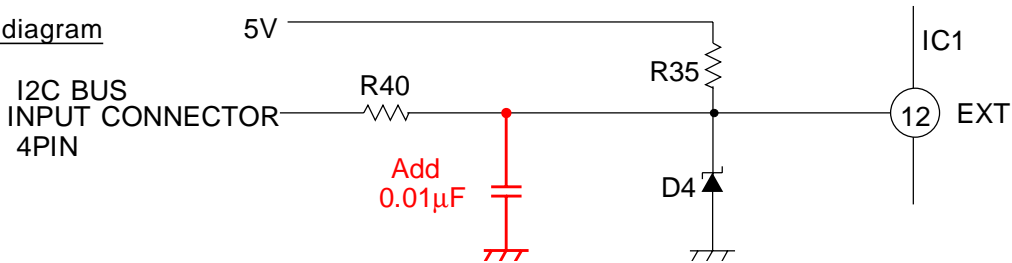
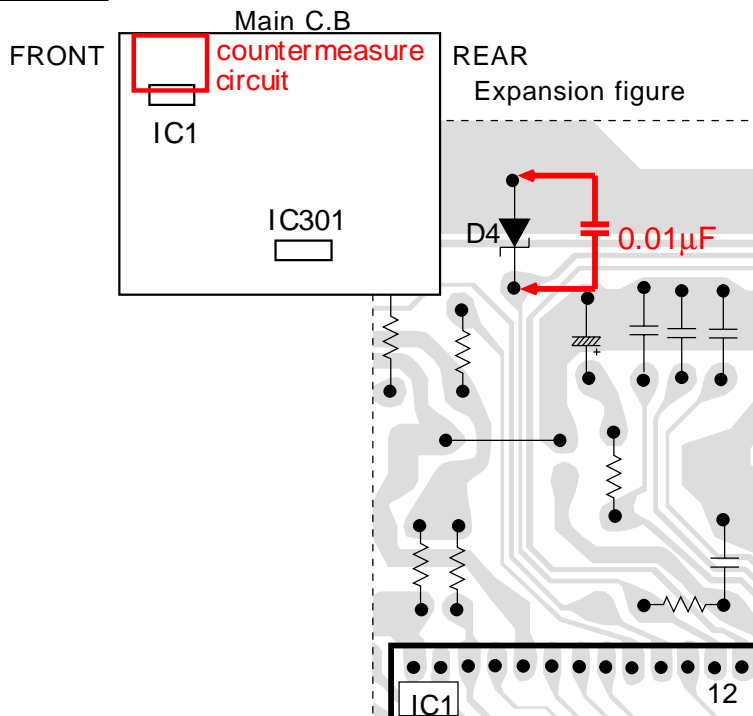
Micro processor may occur malfunction due to the noise of EXT terminal.
To prevent malfunction, attach the condenser 0.01μF parallel to D4 on the reverse side.

*Be sure with glue after attaching the condenser.

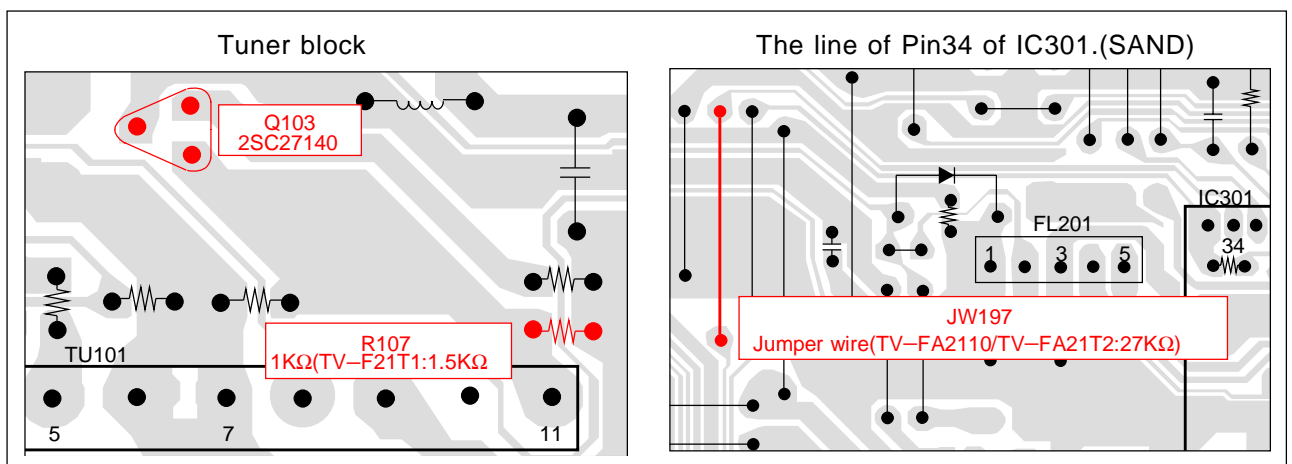
Circuit 1

The improper use of spare parts will be cause of the beat noise on Aerial.
 When the buzz noise arises on Aerial or line input of TV-F21T1(Circuit 1), mount the 27KΩ instead of JW197.

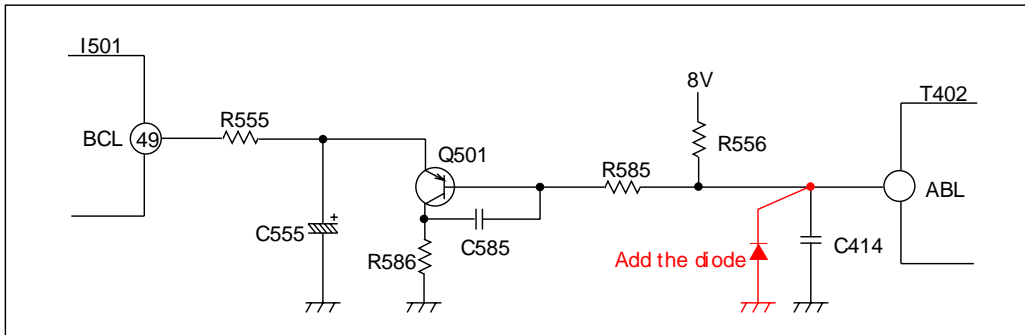
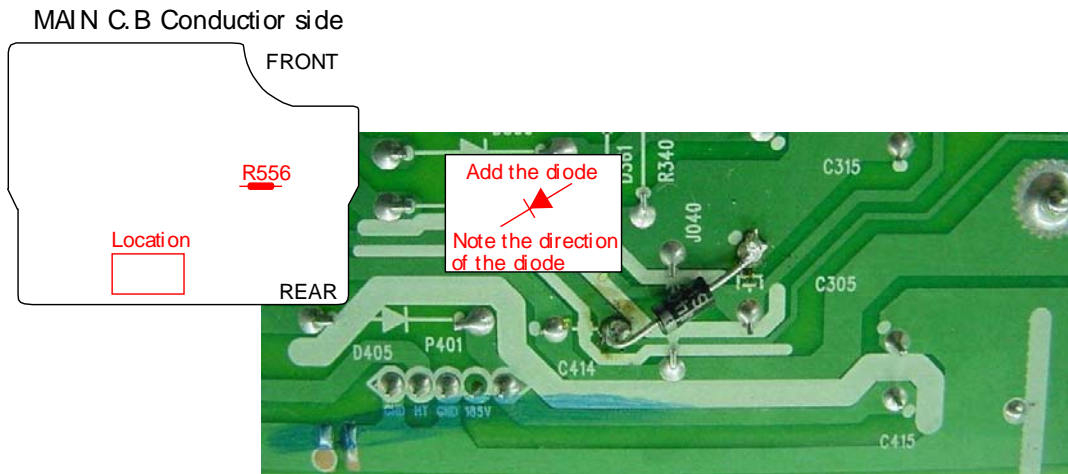
- 1) Replaced a CRT.
- 2) A failure of R556 was confirmed.

1. Add the diode between C414 and C305(GND) as the picture below.
2. Fix it with a glue.
3. Confirm a value of resistor, a color of R556, and replace it if found any defect.

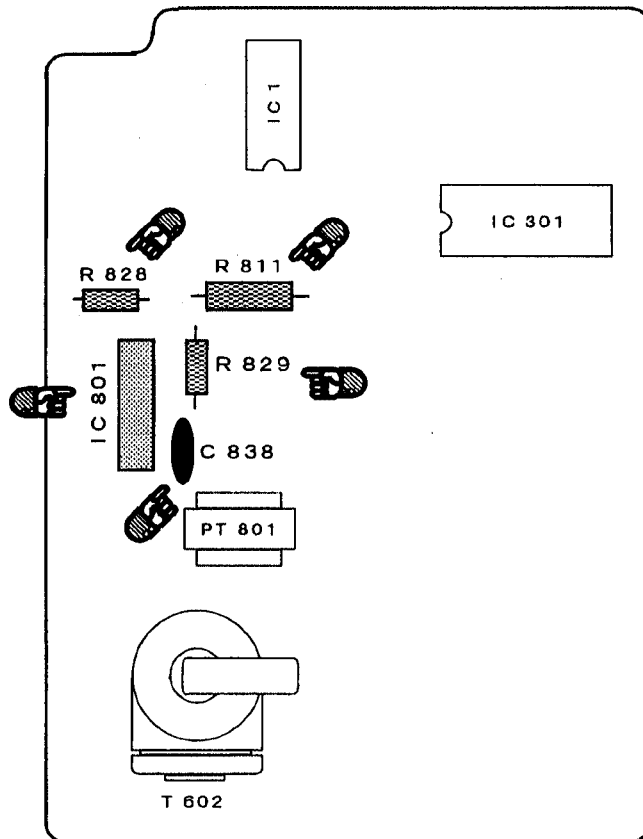
FRONT SIDE

MODEL S : TV-A145, TV-A205, TV-A215
 SUBJECT : No power is turned on.
 DESCRIPTION : The power may not be turned on due to a fault of the ceramics capacitor (C838) on the power circuit. Regardless of the indicated phenomenon of faulty details, exchange the object capacitor (C838) with one of the specified type. If any peripheral part is damaged and the equipment cannot be operated at the same time, exchange the part with a new one.

- Specified capacitor: C838
 1000P • 1K K → 1000P • 1K K R

- When the equipment does not operate due to a faulty peripheral part, exchange the following parts with new ones.
 IC801, R811, R828, R829

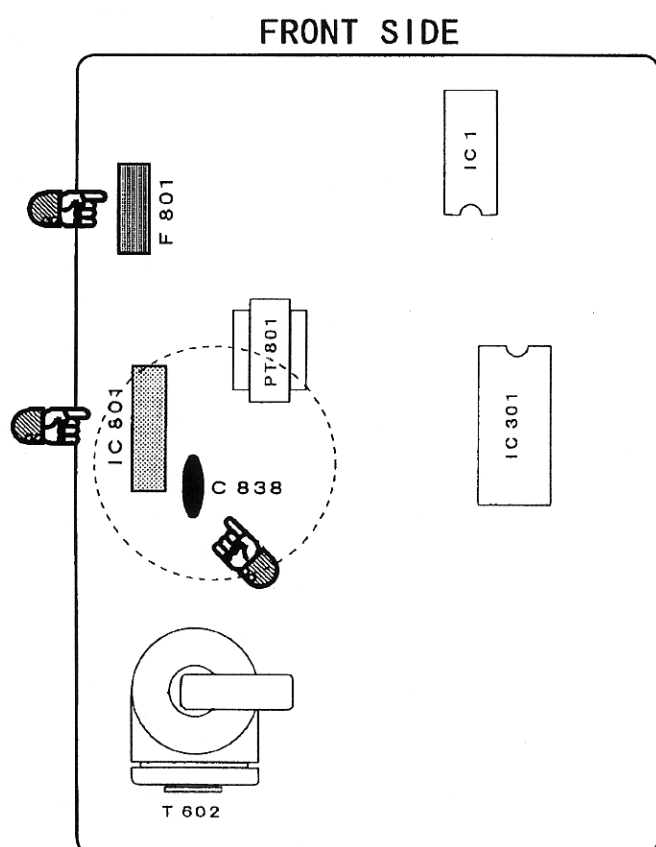
- MODEL S : TV-C142, TV-C202
 SUBJECT : No power is turned on.
 DESCRIPTION : The power may not be turned on due to a faulty ceramics capacitor (C838) on the power circuit. Regardless of the indicated phenomenon of faulty details, exchange the undesirable capacitor (C838) with a one of the specified type. At the same time, if any peripheral part is damaged and the equipment cannot be operated, exchange the part with a new one.

- Specified capacitor: C838
 1000P • 1K K → 1000P • 1K K R
- When the equipment does not operate due to a faulty peripheral part, exchange the following parts with new ones.
 IC801, F801
- * The position of C838 is slightly different between boards with the end numbers 11 and 12. Therefore, take the following precautions on installation.

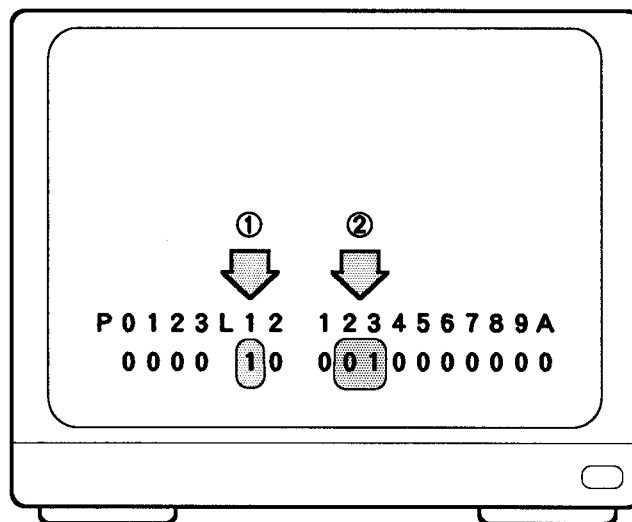
SUBJECT : Service manual of the model in question contains an error in service-mode setting values to be specified after replacing EEP ROM. Setting of erroneous value may lead to a failure in Portuguese OSD display.

- Correct the service manual setting of OSD display into values shown in the following figure.
- After a repair, set to the specified values .

The correct values for ① and ② of TV-A215RH must be set as shown in the figure. After repairing the EEP ROM ,set the values as shown in the figure.

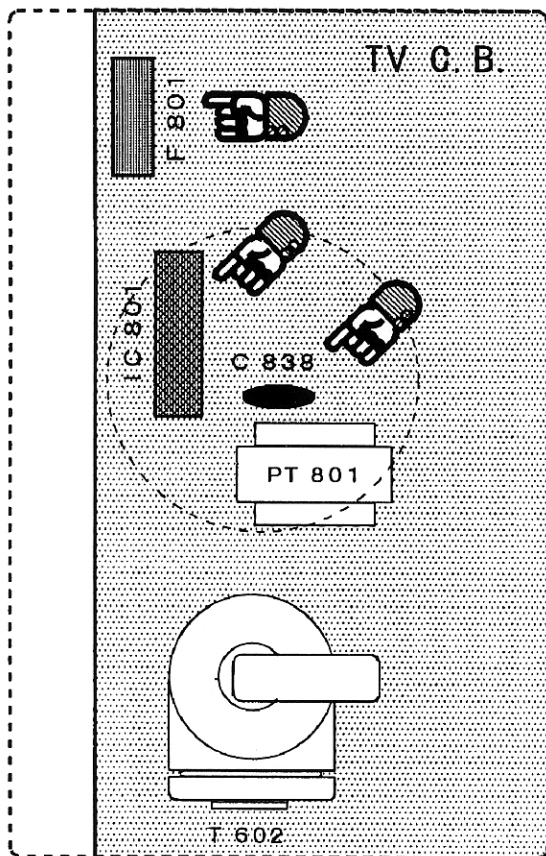
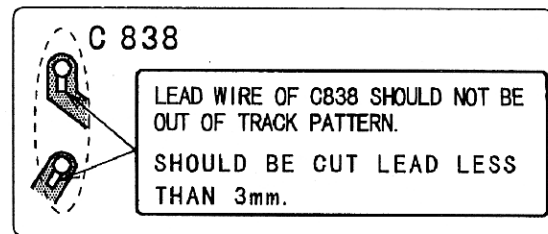
MODEL : TV-C2120 DH
 SUBJECT : No power is turned on.
 DESCRIPTION : The power may not be turned on due to a faulty ceramics capacitor (C838) on the power circuit. Regardless of the indicated phenomenon of faulty details, exchange the undesirable capacitor (C838) with a one of the specified type. At the same time, if any peripheral part is damaged and the equipment cannot be operated, exchange the part with a new one.

- Specified capacitor: C838
 1000P • 1K K → 1000P • 1K K R
- When the equipment does not operate due to a faulty peripheral part, exchange the following parts with new ones.
 IC801, F801
- During soldering, take great care to the following respects.

Ref.	Part Name	Part No.	Remarks
C838	CAP, CER 1000P-1K K R	87-A10-832-01/08	CHANGED FROM 87-016-515-080
IC801	IC, STR-S6707	87-A20-517-010	
F801	FUSE, 4A 250V T 218	87-035-458-010

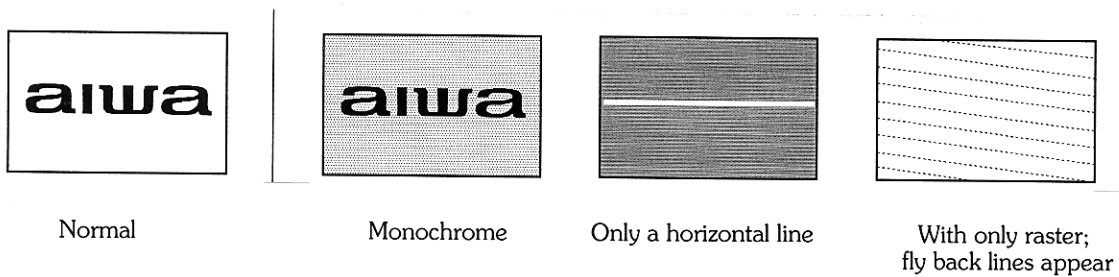
MODEL : TV-1452 NH
 SUBJECT : Abnormal screen display
 CONTENT : Electric discharge on the CRT may damage the CRT C. B transistor (2SC2482, 2SC1815Y) and the TV C. B IC201 (TA8825AN). In these cases, the following symptoms are present.
 *As electric discharge on the CRT seldom occurs, it is therefore not caused by a malfunction in the CRT.

REMEDY : Replace the damaged parts. Then, to prevent a repetition of those problems, follow steps (1- 5) for the circuit modification described below.
